**FAC – Lower Water Street Roof Replacement
U&U**

UARB APPROVAL SHEET

ROOF CONDITION ASSESSMENT REPORT

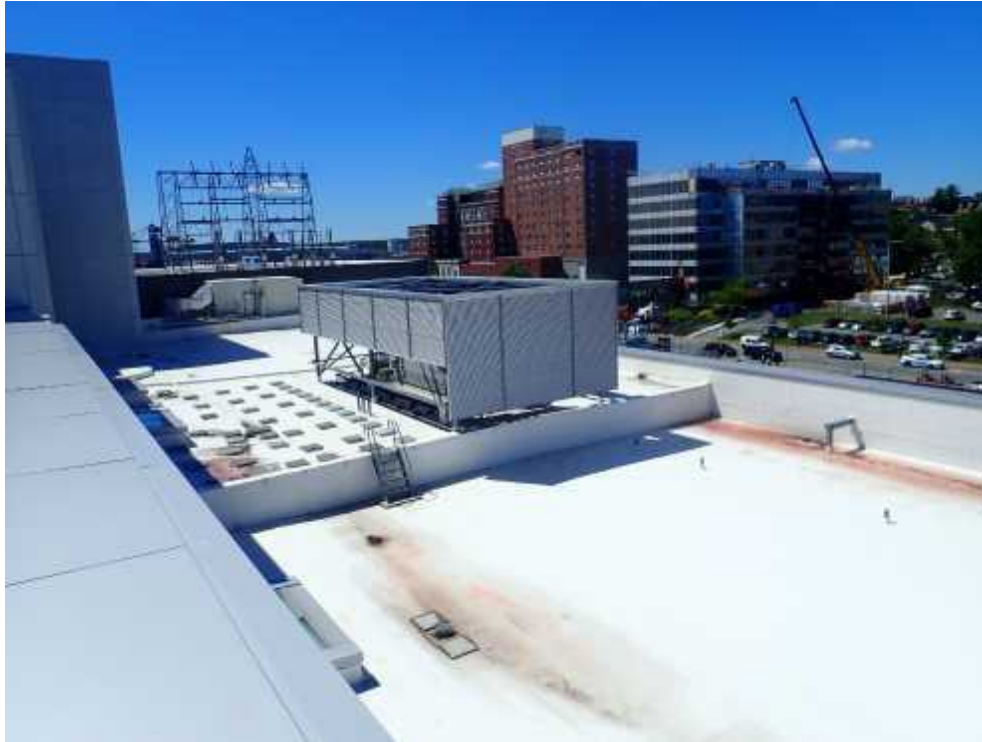
Photograph 3: Roof Area 1.1 – areas of blow off are visible where patio pavers have been used as counter weights.

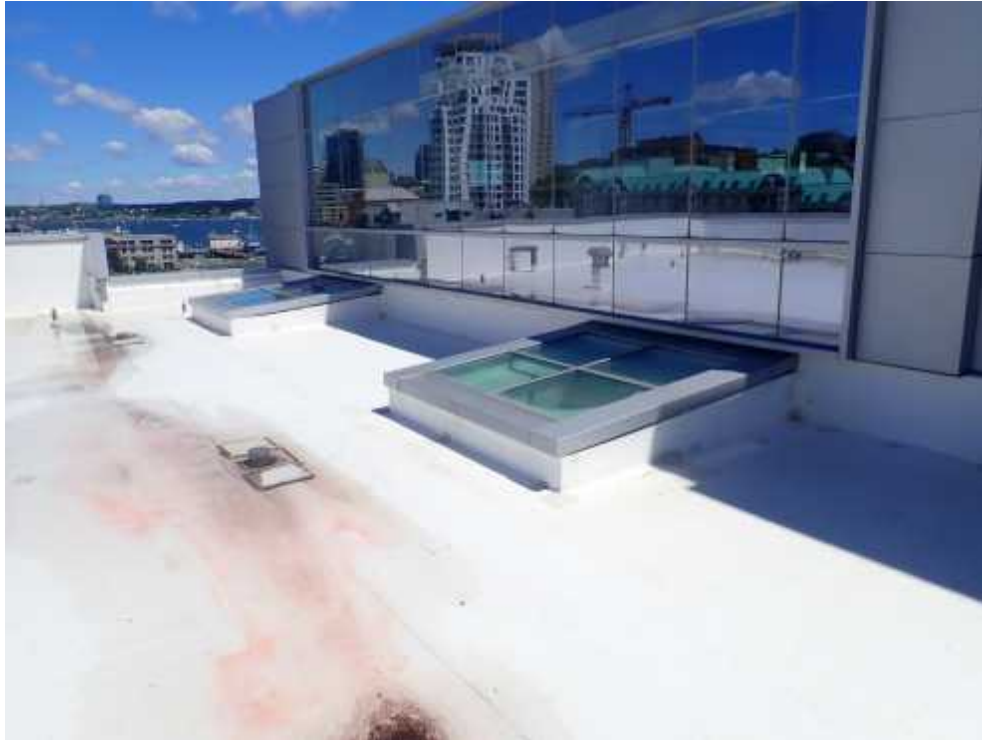
Photograph 4: Roof Area 1.1 – Skylight locations where reported leaks have been occurring.

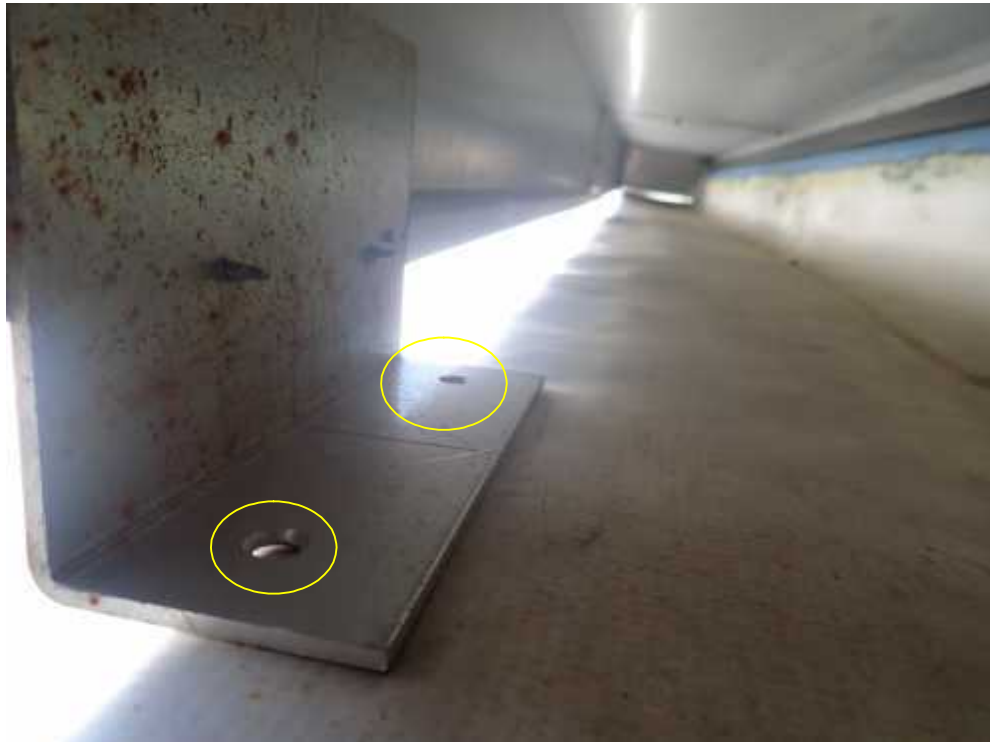
Photograph 5: Roof Area 1.1 – Skylight does not appear to be secured down.

1. There are reoccurring roof leaks at the north east corner of this roof section and around the existing skylights. The skylights do not appear to be secured to the curb with any observed fasteners. (Photograph 5).

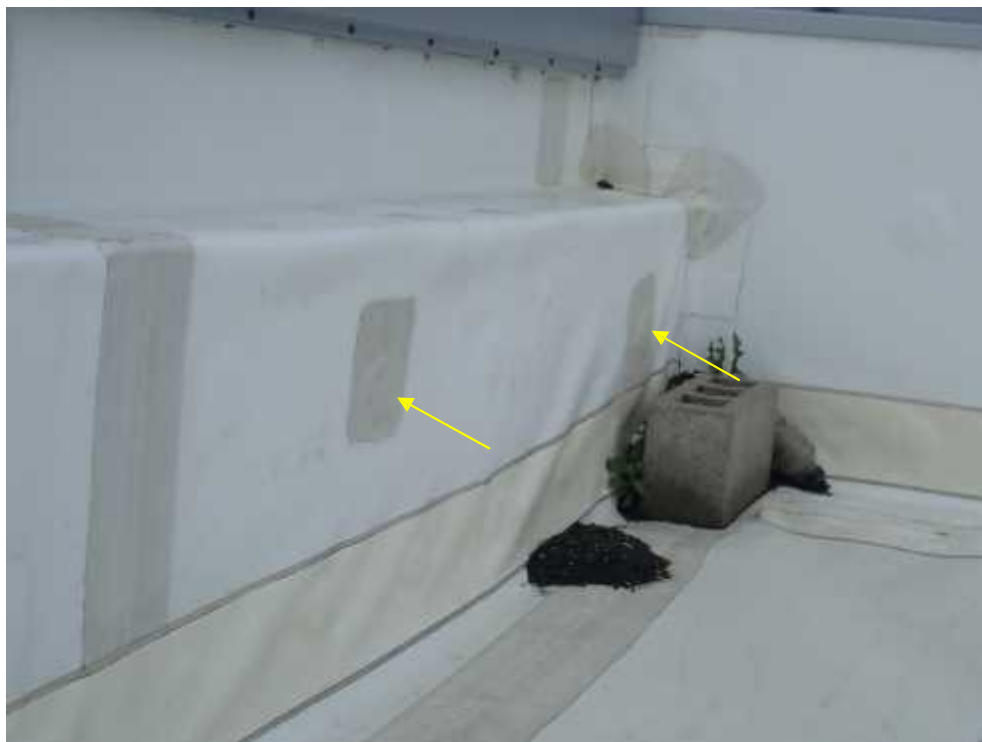
Photograph 6: Roof Area 1.1 – north east corner, wind uplift damage. Concrete masonry unit being used as weight. Also visible are mechanical fasteners holding membrane down to wall.

2. The existing membrane has suffered wind damage in the north east corner in a previous wind storm. Repairs using mechanical fasteners and cover strips have been completed, however excessive tenting/membrane separation is evident around the perimeter where the blow off occurred. (Photograph 6).

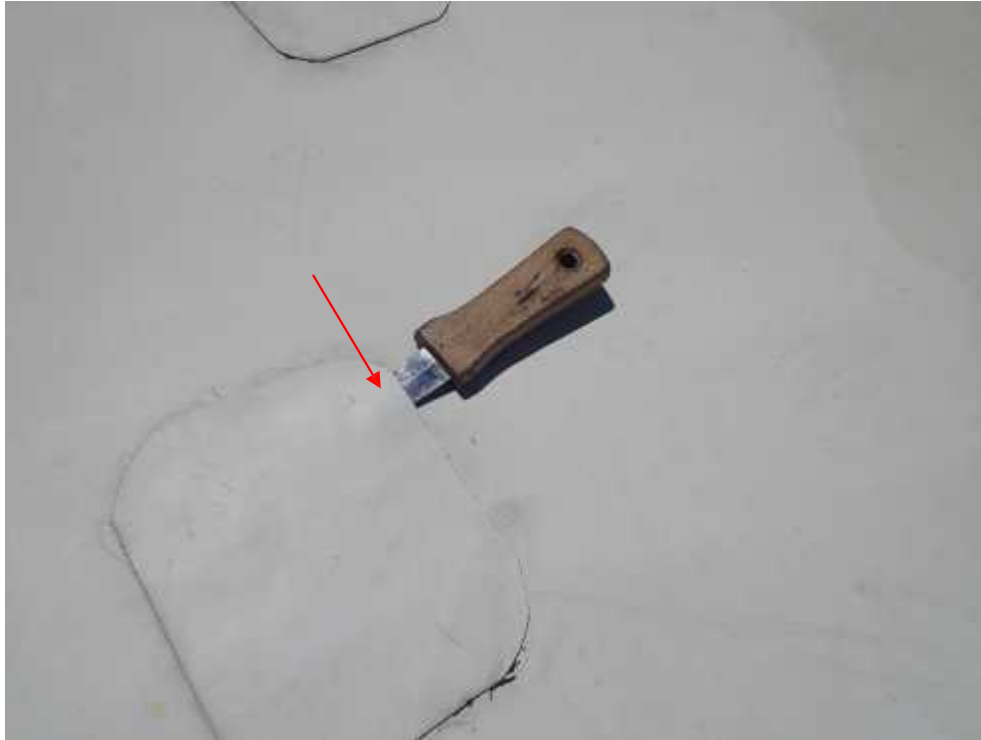
Photograph 7: Roof Area 1.1 – previous patch repairs that do not appear to have been heat welded entirely.

3. Minor membrane de bonding is also evident on the field in various areas, possibly caused by water infiltration saturating the recovery board. Previous repairs were observed (Photograph 7).

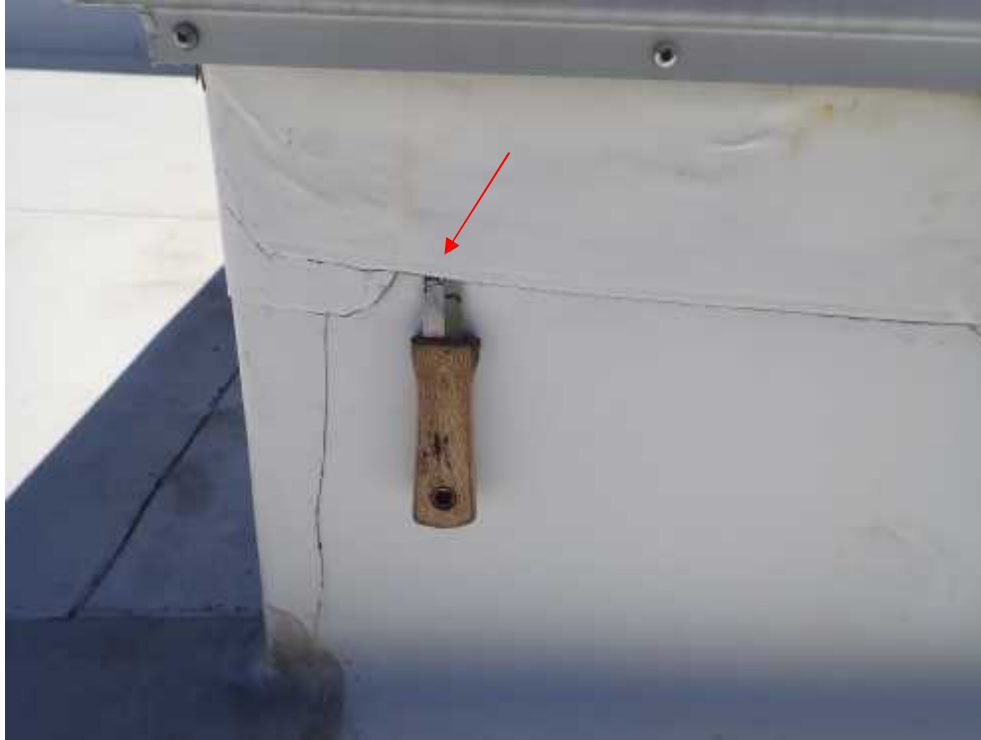
Photograph 8: Roof Area 1.1 – membrane seam not fully sealed around roof penetration duct work.

6. There are multiple areas around the curbs and perimeter wall where the membrane seams were not fully sealed. (Photograph 8)
7. Multiple membrane patches on the field where also improperly sealed. (Photograph 7).

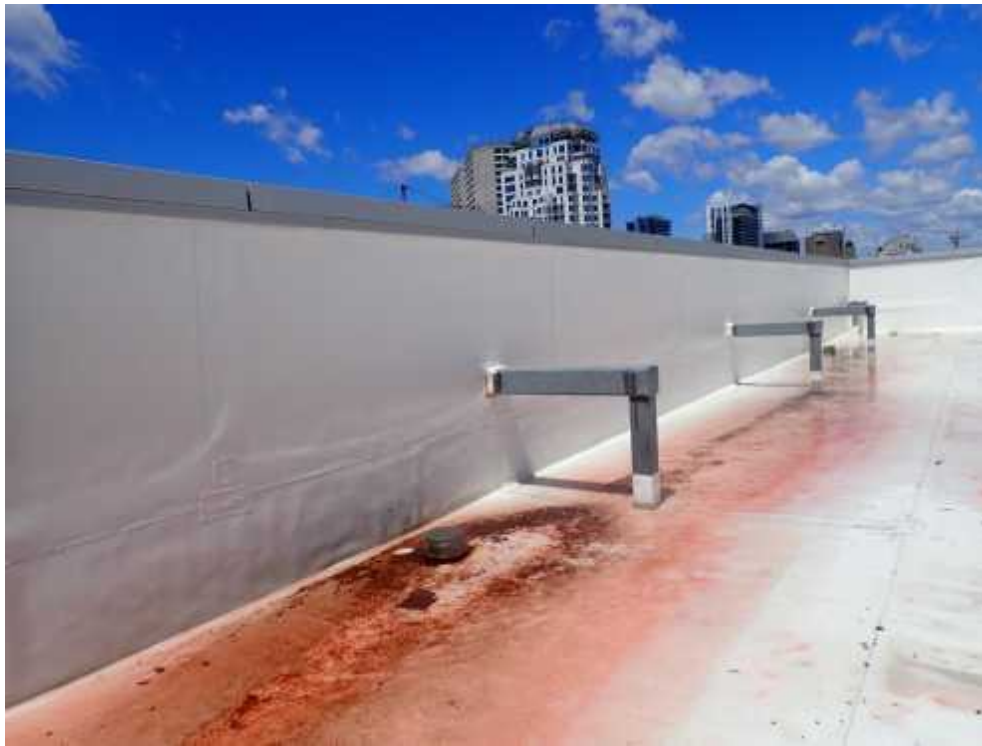
Photograph 9: Roof Area 1.1 – excessive standing water is evident due to build up around the roof drains on this roof area.

8. Excessive standing water is evident due to debris build up around the roof drains. (Photograph 9 and 10)
9. The metal support posts are missing the securement strips around the top of the TPO membrane. (Photograph 11 and 12)

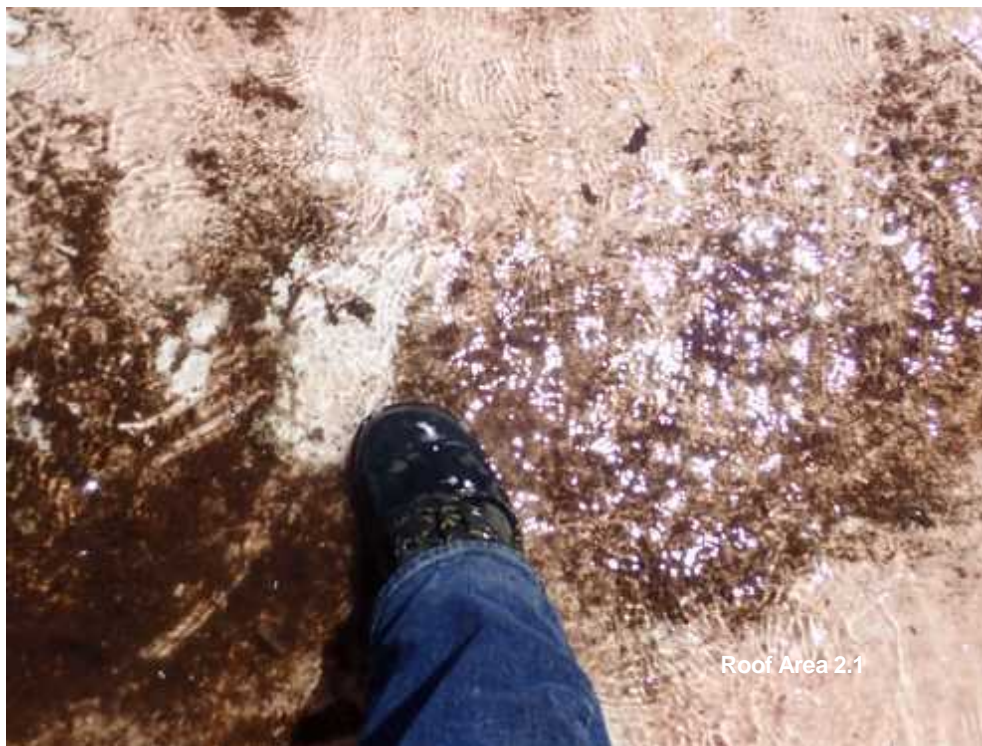
Photograph 10: Roof Area 1.1 – excessive standing water observed on this roof area.

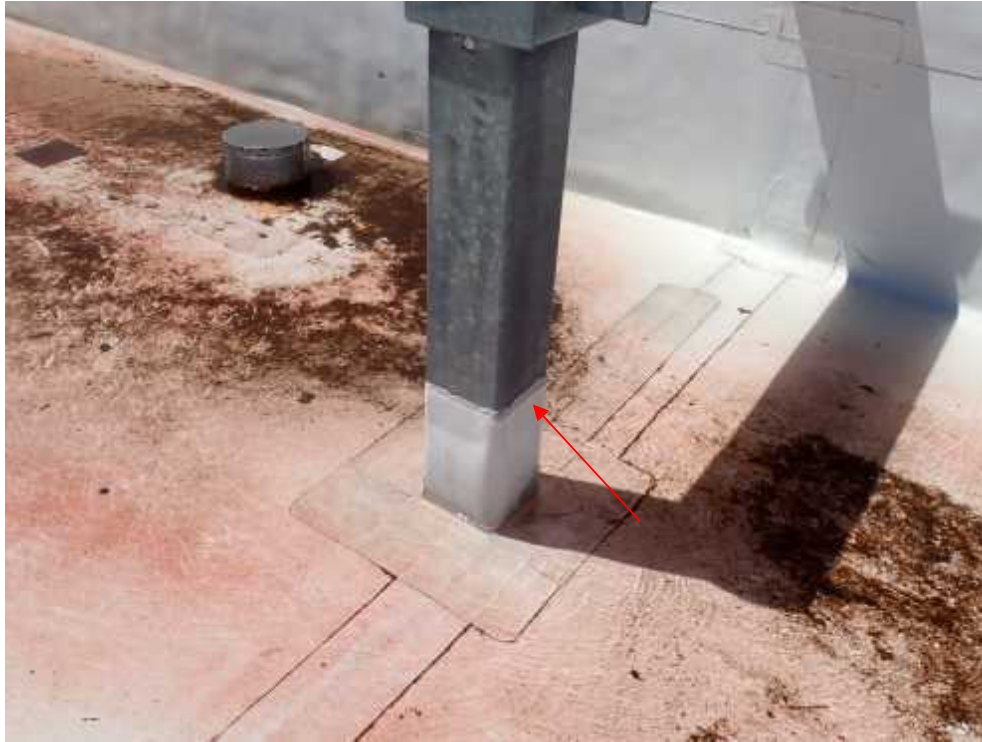
Photograph 11: Roof Area 1.1 – metal support post does not have a securement strip around the post at the top of the TPO membrane termination.

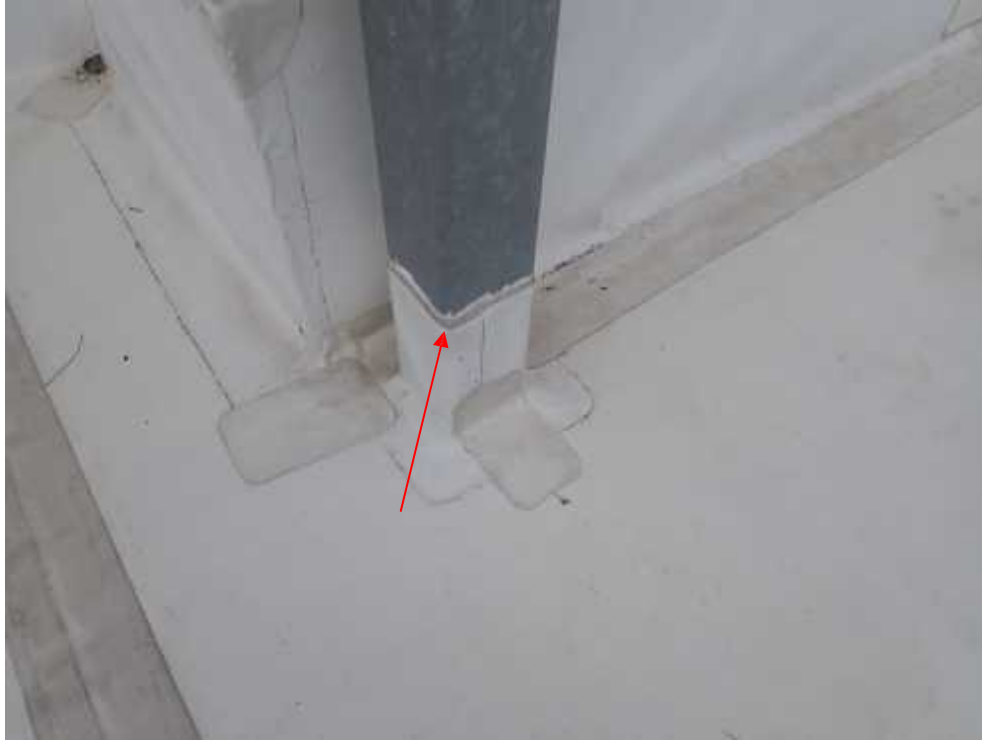
Photograph 12: Roof Area 1.1 – metal support post is missing the securement strip at the top of the post where the TPO membrane terminates.

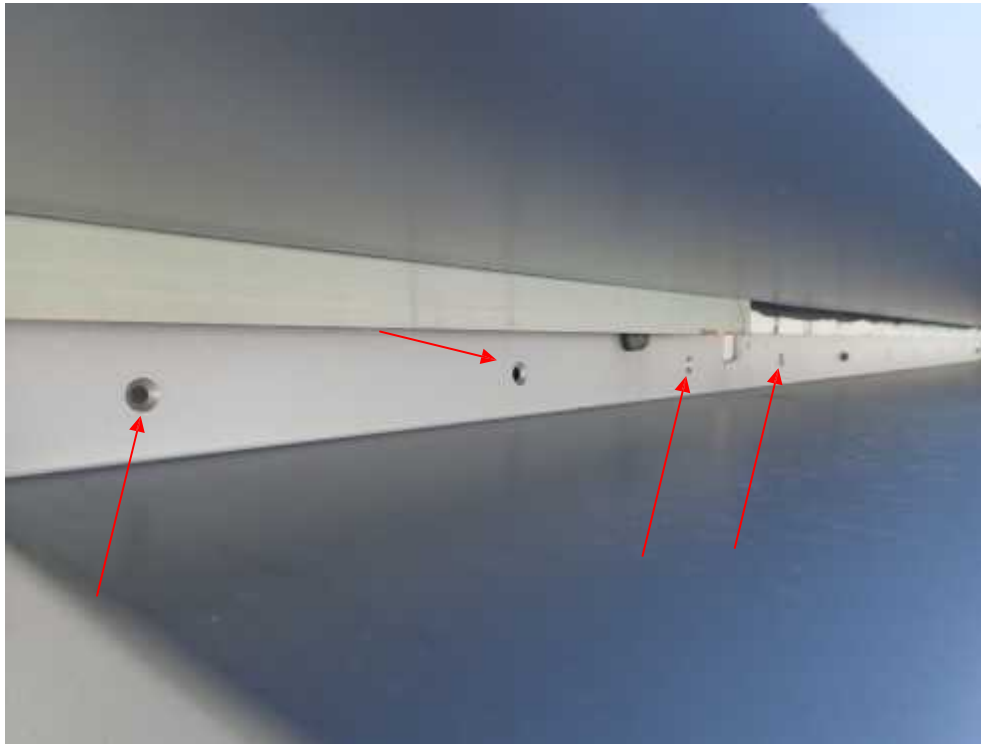
Photograph 13: Roof Area 1.1 – skylight is missing multiple fasteners at the skylight-to-wall transition.

10. The existing skylights are improperly secured to the curb allowing excessive movement to occur. Sealant separation is evident around the existing skylight frames in multiple areas. Multiple metal fasteners are missing around the flashing leaving them improperly secured. (Photograph 13 and 14)

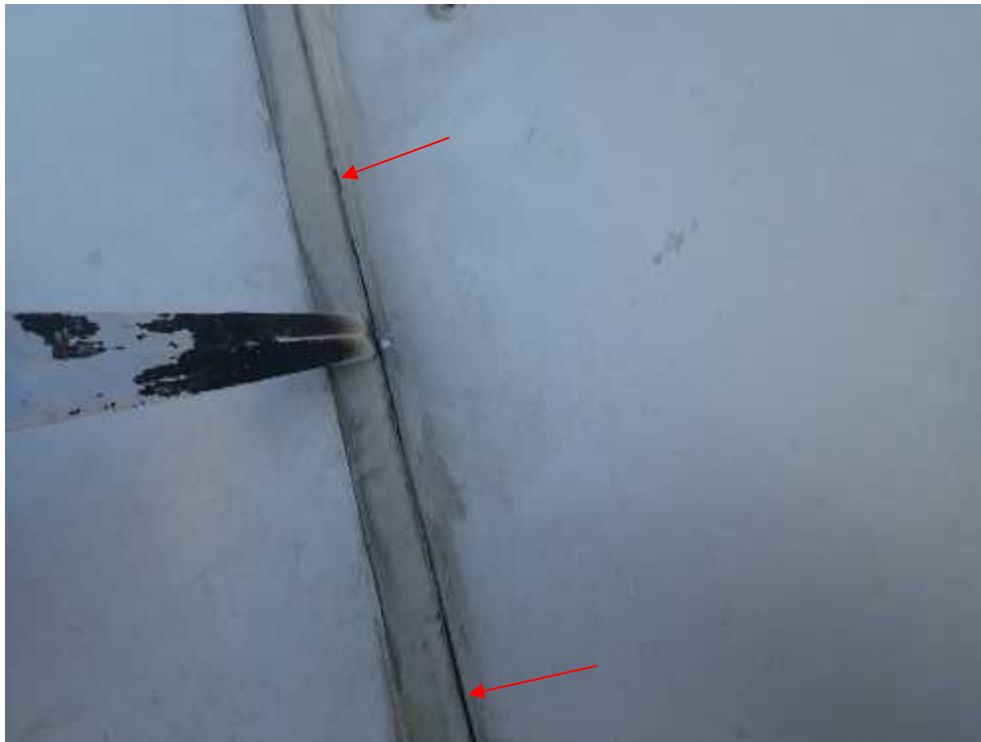
Photograph 14: Roof Area 1.1 – sealant separation between skylight frame members.

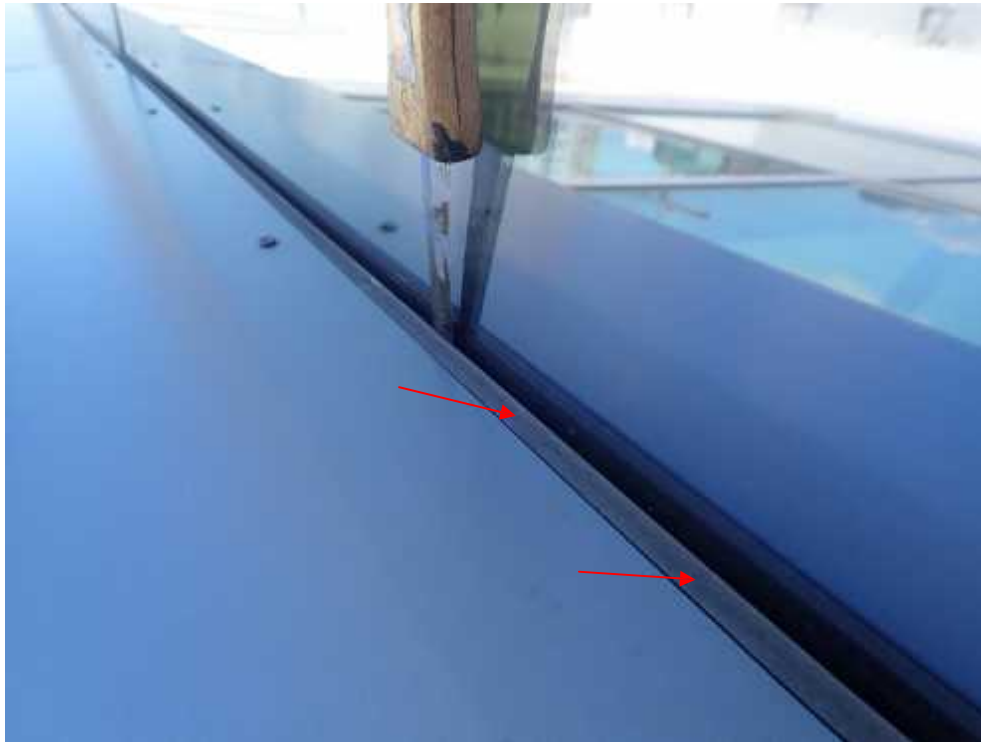
Photograph 15: Improperly secured flashing and pressure plates around the window frame.

11. The window trim on the wall is also improperly secured, causing separation between the windows and flashing in multiple areas. This is allowing water to run in behind the sky lights in various areas. (Photograph 15 and 16)

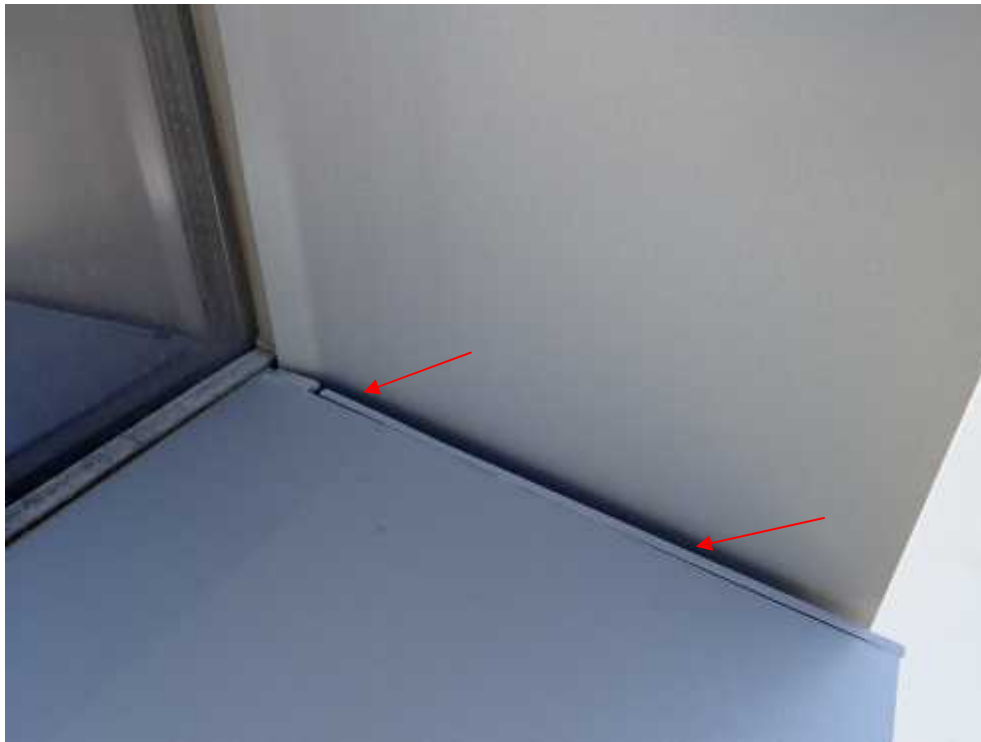
Photograph 16: Roof Area 1.1 – separation at the window frame above roof membrane termination.

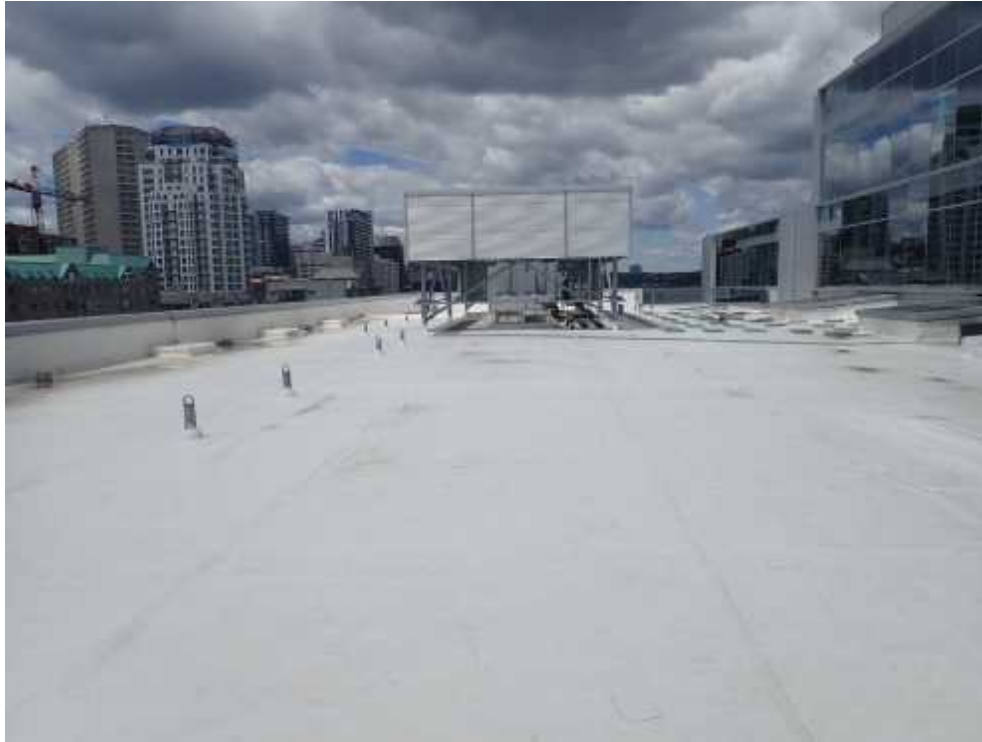
Photograph 17: Roof Area 1.2 – overall view looking north. Area with paving stones is visible where membrane has separated from roof assembly.

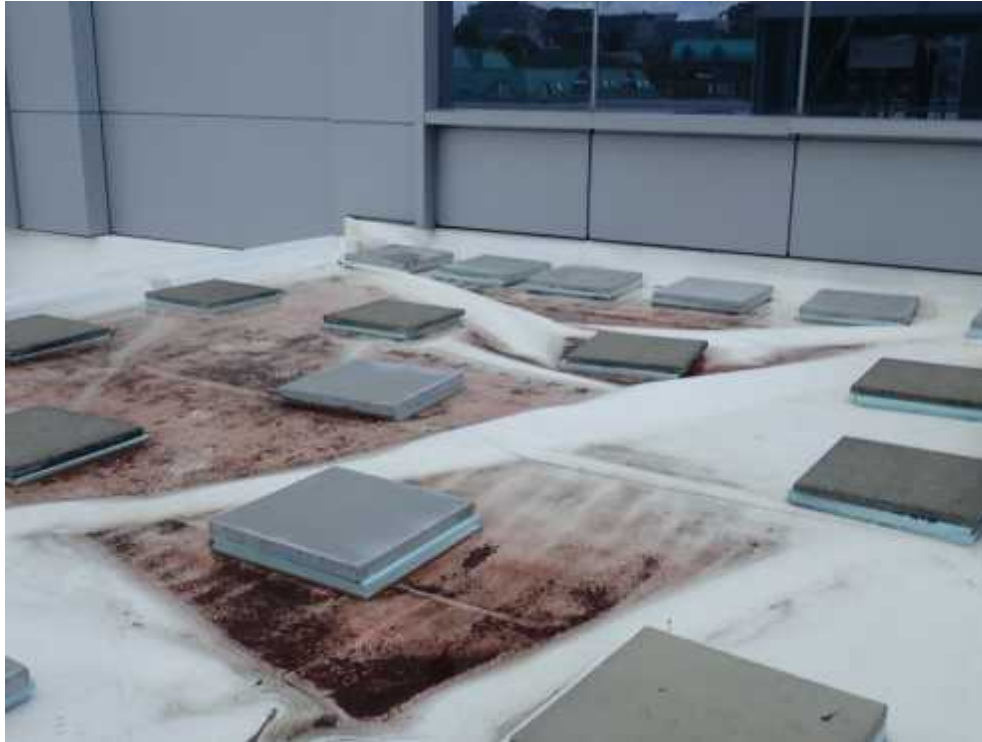
Photograph 19: Roof Area 1.2 – close up of north east section of roof where wind damage was observed. Overall area of wind damage is approximately 50'x70'.

1. The existing membrane has suffered significant wind damage in a previous wind storm. The membrane has fully separated from the recovery board on an area of approximately 50'x70'. (Photograph 19 and 20).
2. Ridging has occurred on the field in multiple areas indicating the membrane has begun to separate from the recovery board. (Photograph 21).
3. Multiple repairs have been completed in various areas, however water infiltration is evident on the east side where the blow off has occurred and around the skylights. (Photograph 22)
4. There are multiple areas where minor membrane separation has occurred on the field seams.
5. There are areas around the curbs and perimeter wall where the membrane seams were not fully sealed. (Photograph 23)

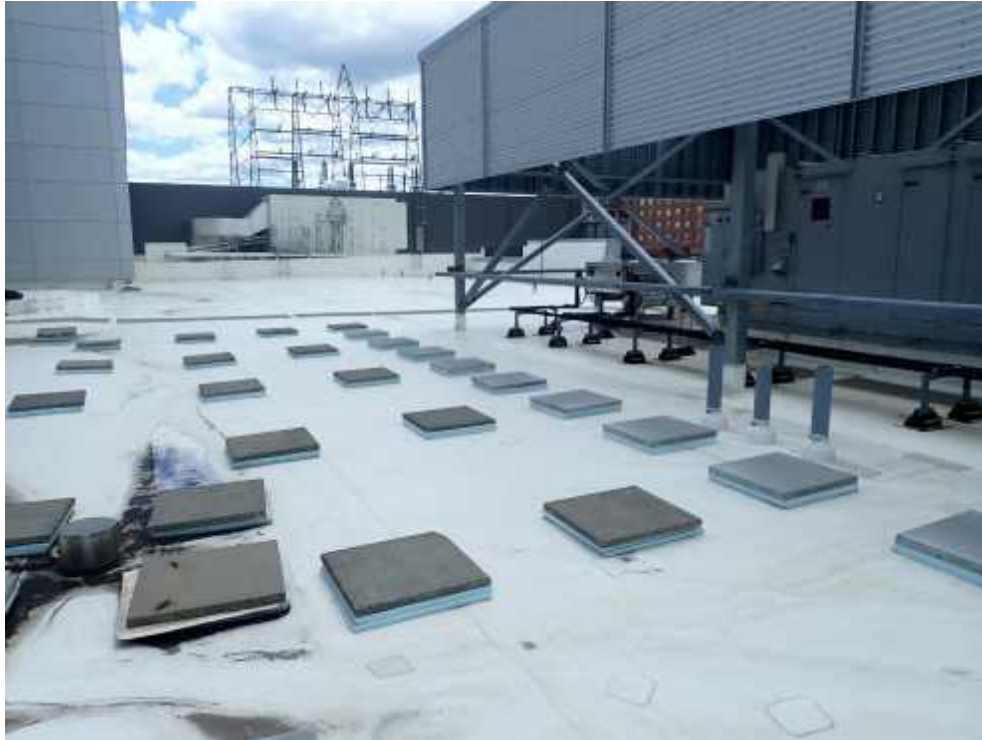
Photograph 20: Roof Area 1.2 – close up of north east section of roof looking south where wind damage was observed.

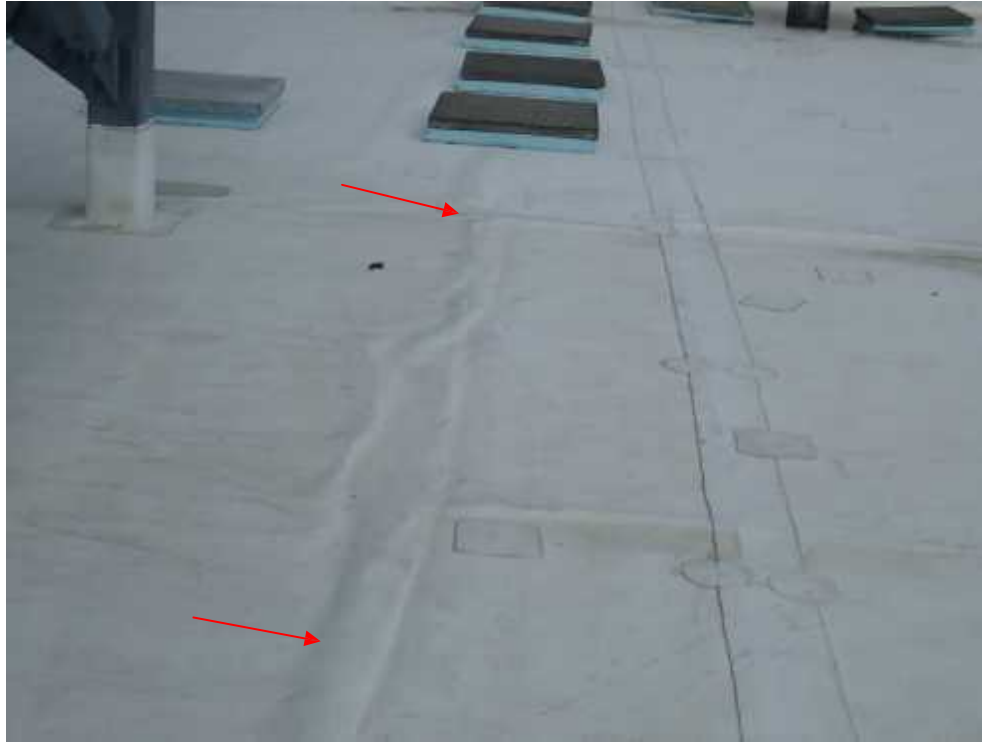
Photograph 21: Roof Area 1.2 – ridging observed adjacent to the mechanical unit supports. Separation between membrane and underlayment board.

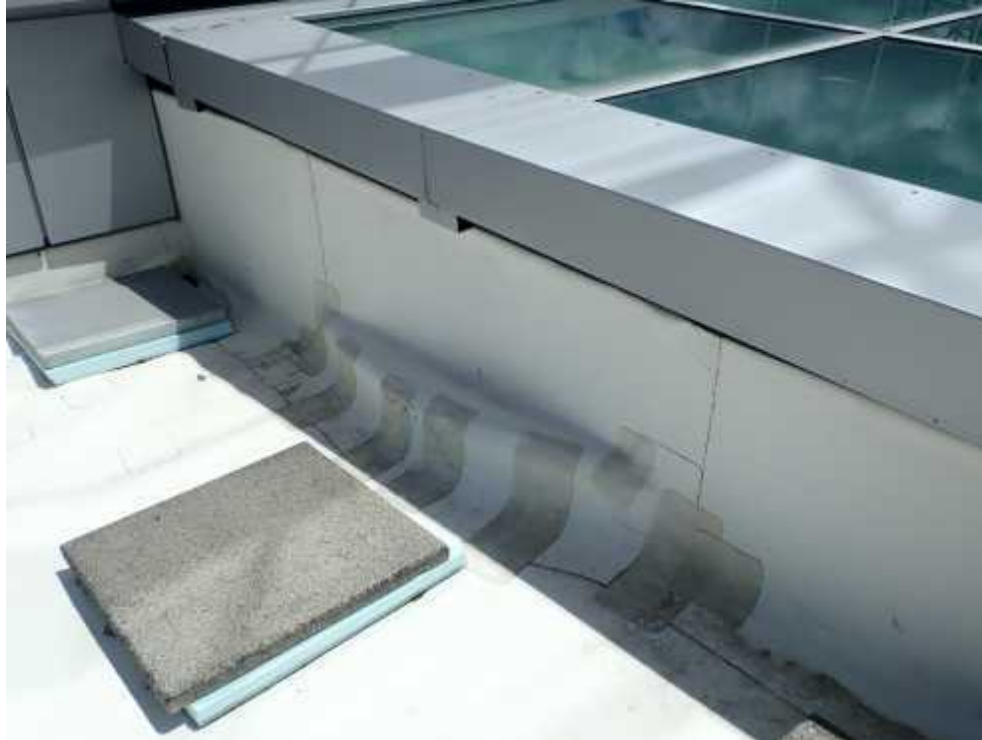
Photograph 22: Roof Area 1.2 – multiple repairs completed adjacent to the skylight assembly. Paving stones being used as a counter weight.

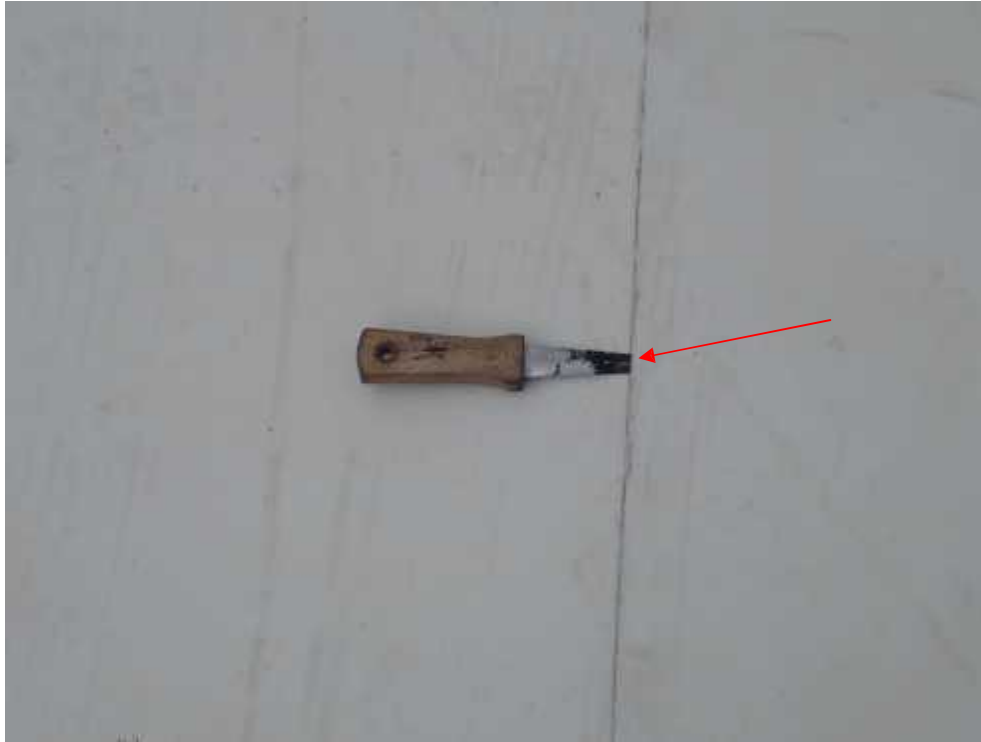
Photograph 23: Roof Area 1.2 – the seam is not fully sealed at this location at the perimeter wall.

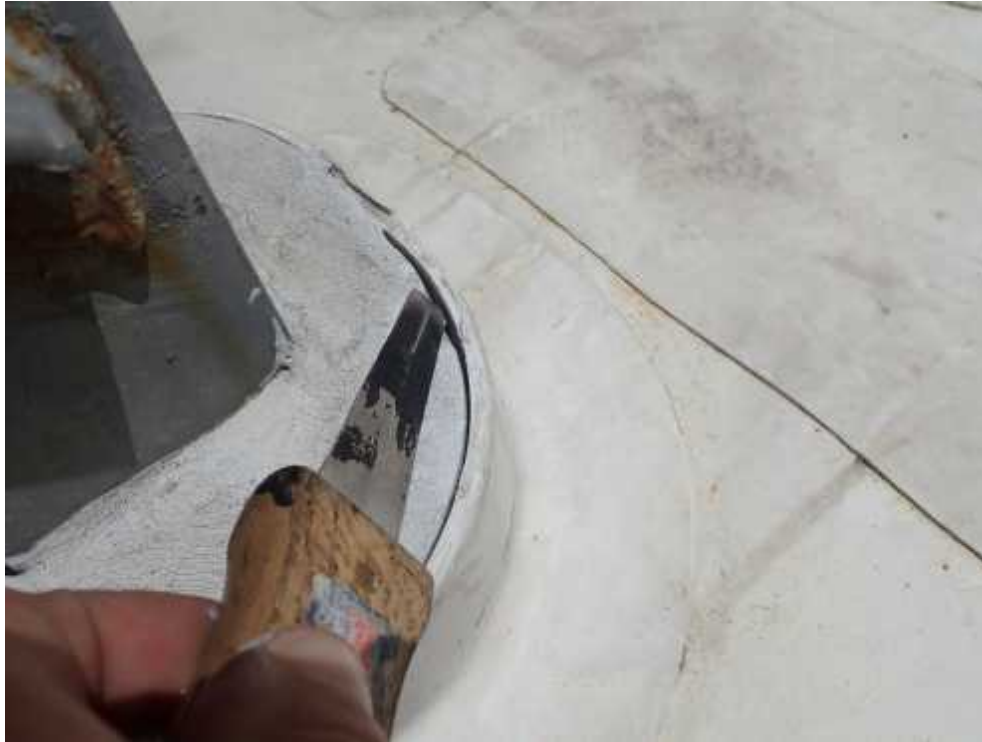
Photograph 25: Roof Area 1.2 – sealant separation at the pitch pocket at the base of the steel support legs.

8. The metal support posts are missing the securement strips around the top of the TPO membrane.
9. Multiple pitch pockets are showing signs of sealant separation. (Photograph 25).

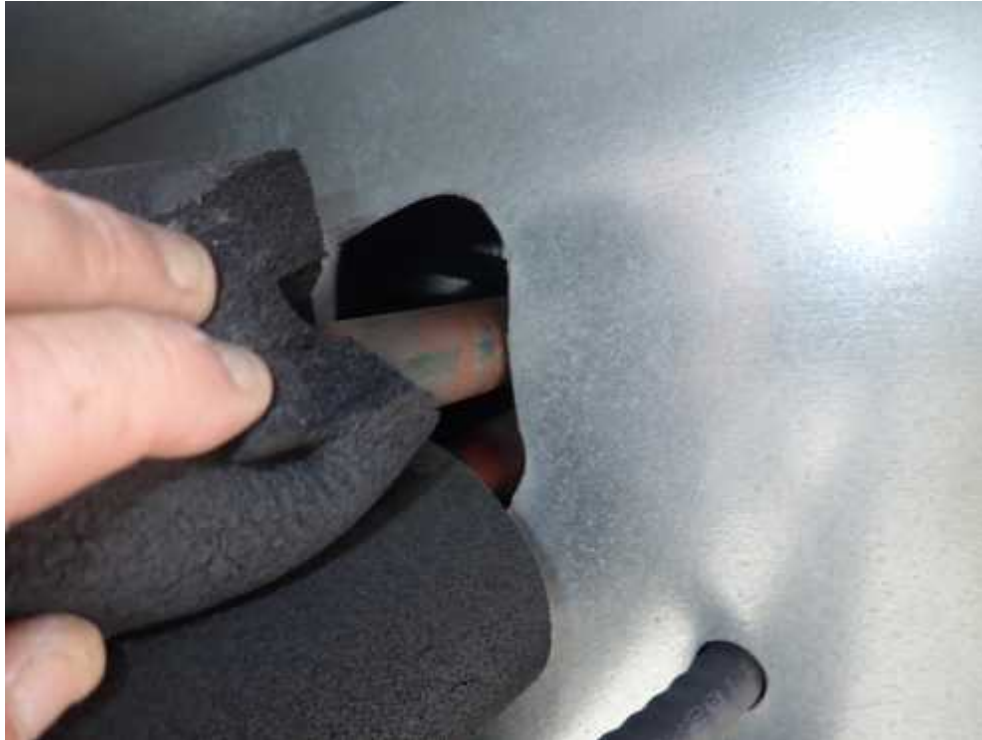
Photograph 26: Roof Area 1.2 – No sealant observed at coolant and electrical penetrations into the mechanical curb.

10. One pipe box is also improperly sealed where the piping runs in to the curb. (Photograph 26).
11. The existing skylights are improperly secured to the curb allowing excessive movement to occur. Sealant separation is evident around the existing skylight frames in multiple areas. Multiple metal fasteners are missing around the flashing leaving them improperly secured. (Photograph 27 and 28).

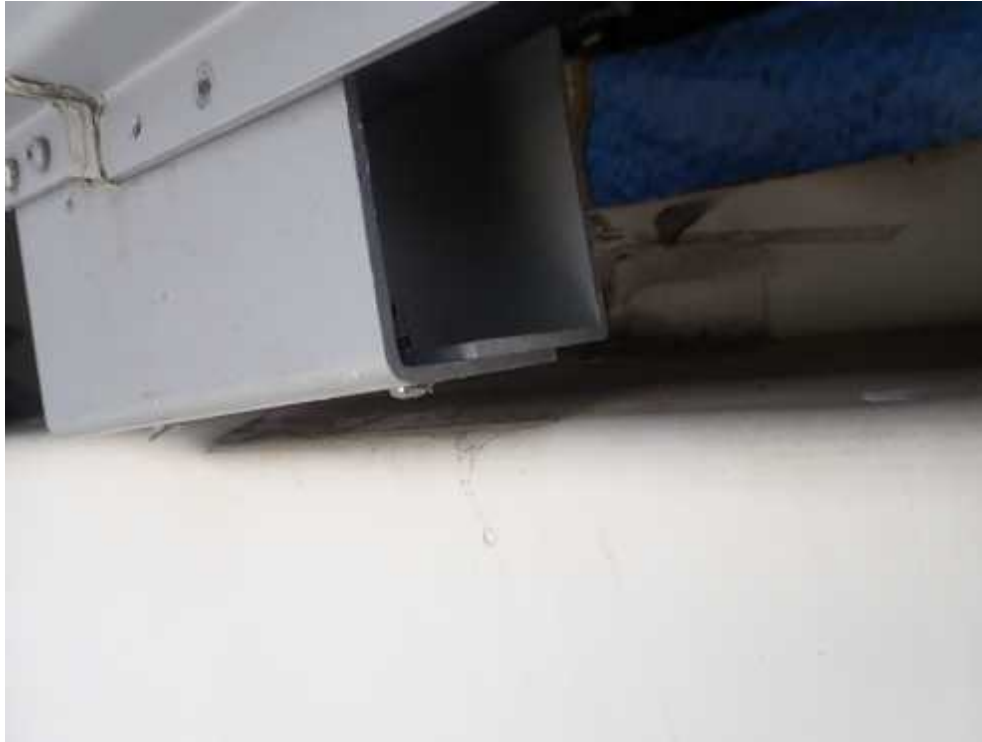
Photograph 27: Roof Area 1.2 – Support bracket for skylight assembly does not bear on curb at all. Skylight assembly is not secured to curb.

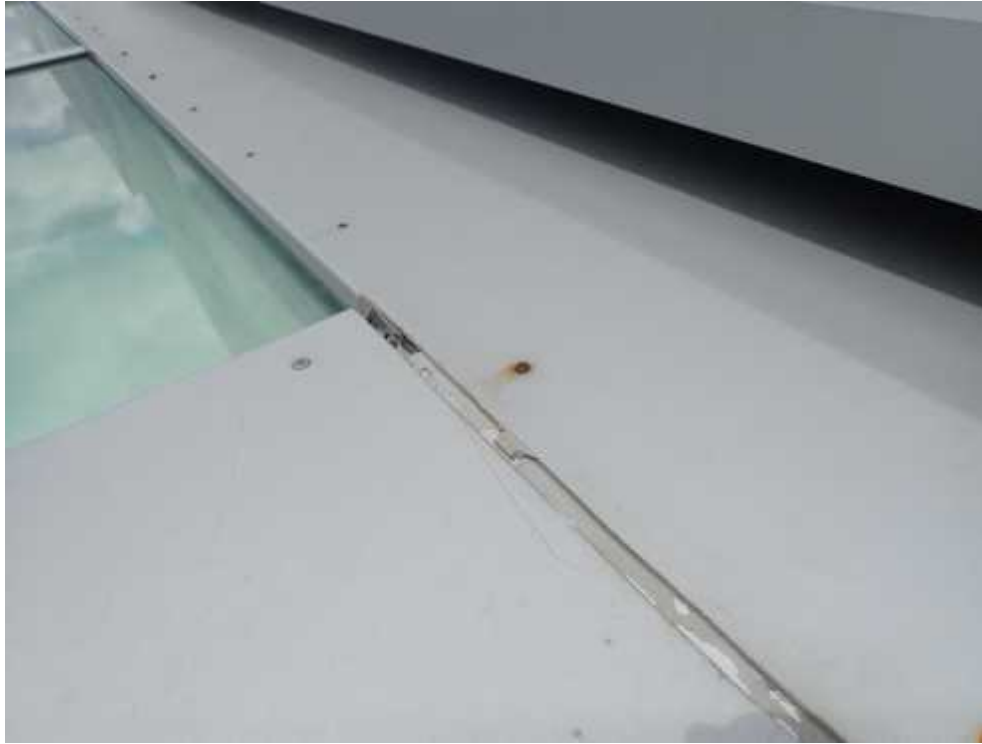
Photograph 29: Roof Area 1.2 – flashing/trim around the skylight assembly at the window-to-wall transition

12. The window trim on the wall is also improperly secured, causing separation between the windows and flashing in multiple areas. This is allowing water to run in behind the sky lights in various areas. (Photograph 29).

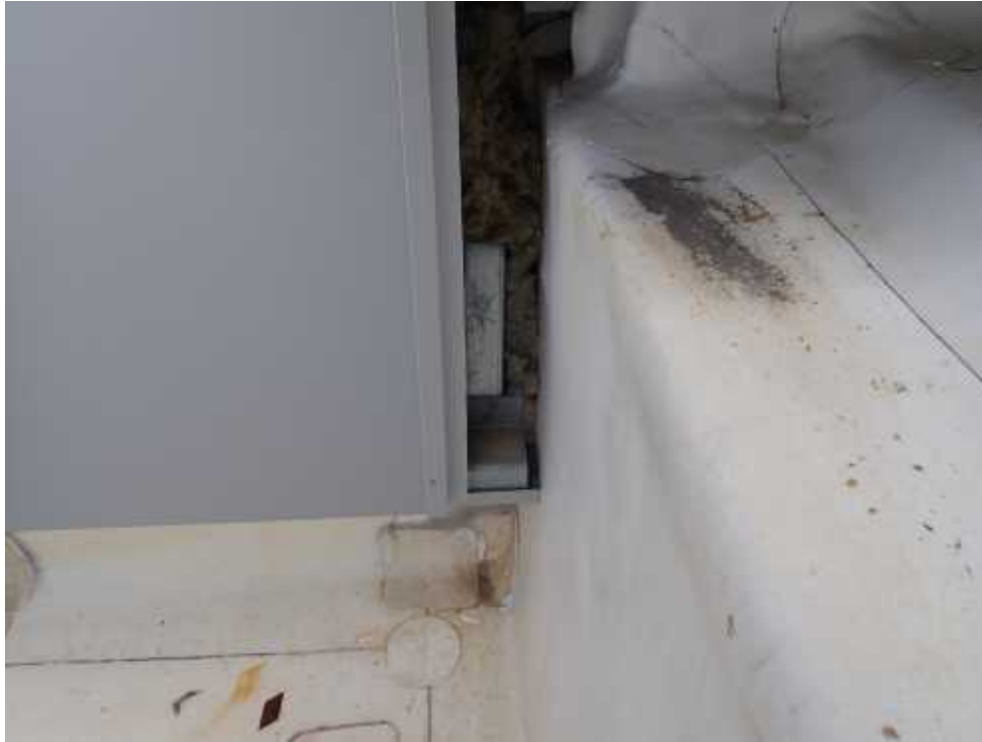
Photograph 30: Roof Area 1.2 – Siding panels missing and poor termination of roofing membrane behind wall.

13. There are also multiple siding panels that are improperly secured in place on the east wall. (Photograph 30)

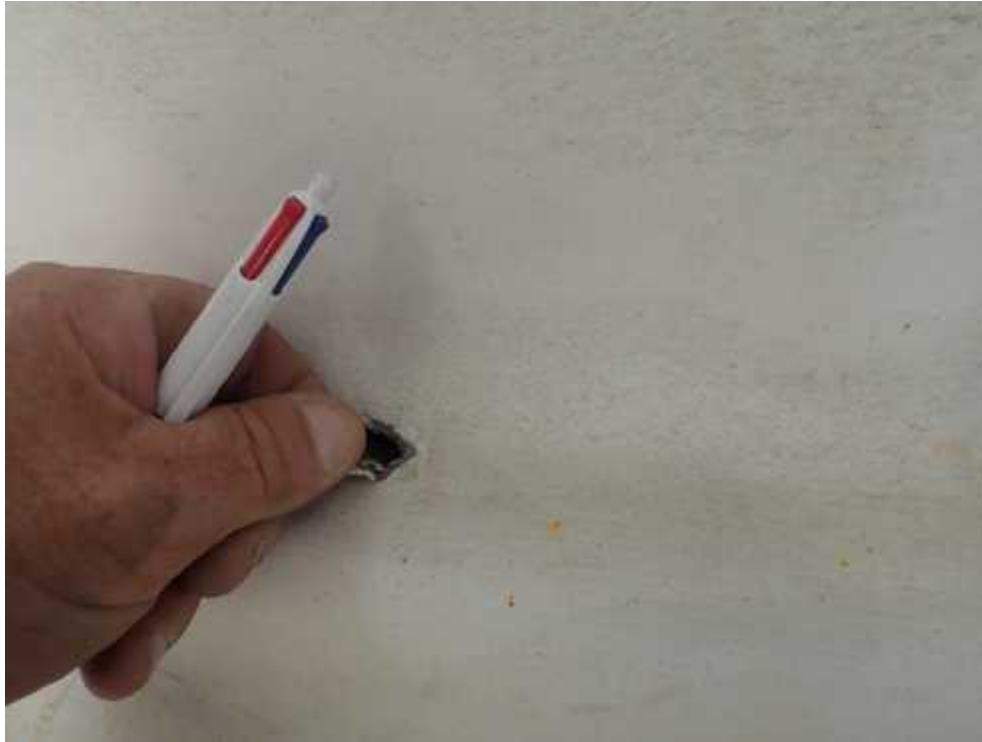
Photograph 33: Roof Area 1.3 – puncture observed in membrane at the curb adjacent to the mechanical unit.

1. The existing membrane is in fair condition and is adhered to the recovery board.
2. Multiple repairs have been completed in various areas and there are no reported leak areas. One membrane puncture was discovered during the review, on the existing roof curb. (Photograph 33).

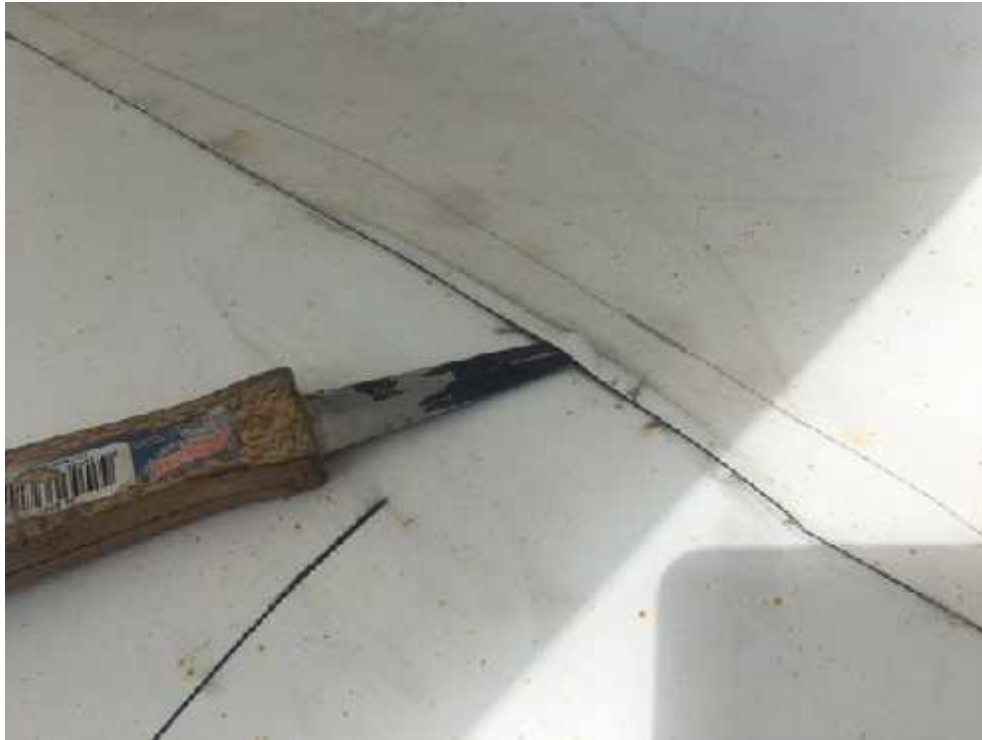
Photograph 34: Roof Area 1.3 – poor heat welding resulting in membrane separation at the field seams.

3. There are areas where minor membrane separation has occurred on the field seams and around the support posts. (Photograph 34).
4. There are areas around the curbs and perimeter wall where the membrane seams were not fully sealed. Two metal support posts are missing the securement strips around the top of the TPO membrane. (Photograph 35 and 36).

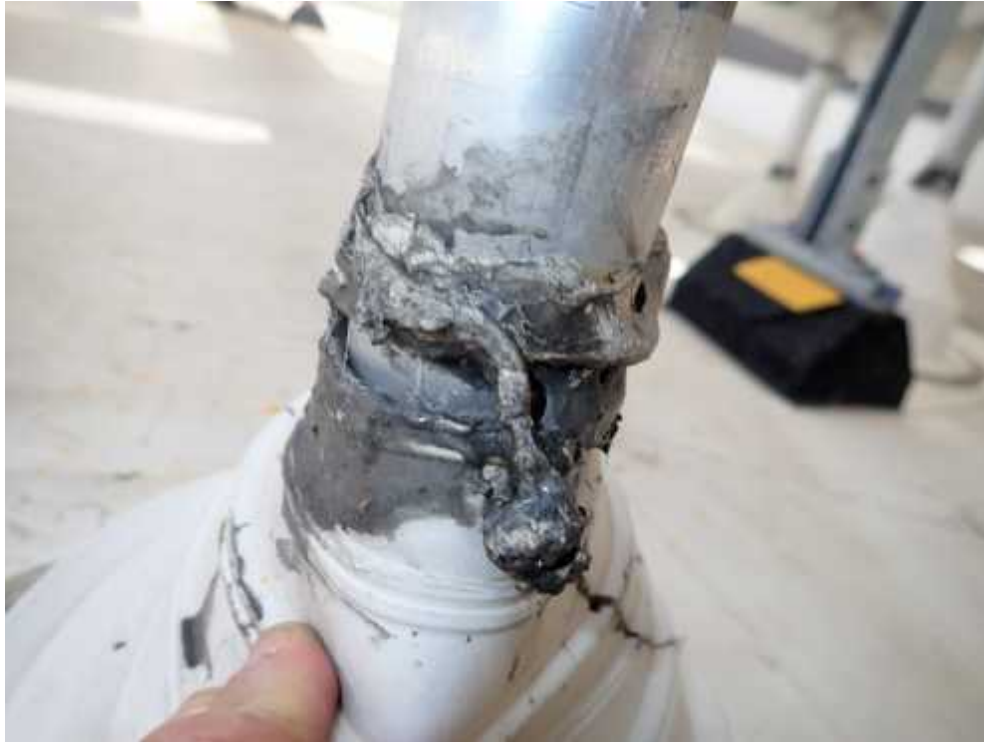
Photograph 35: Roof Area 1.3 – poor sealant and membrane termination at the support post base.

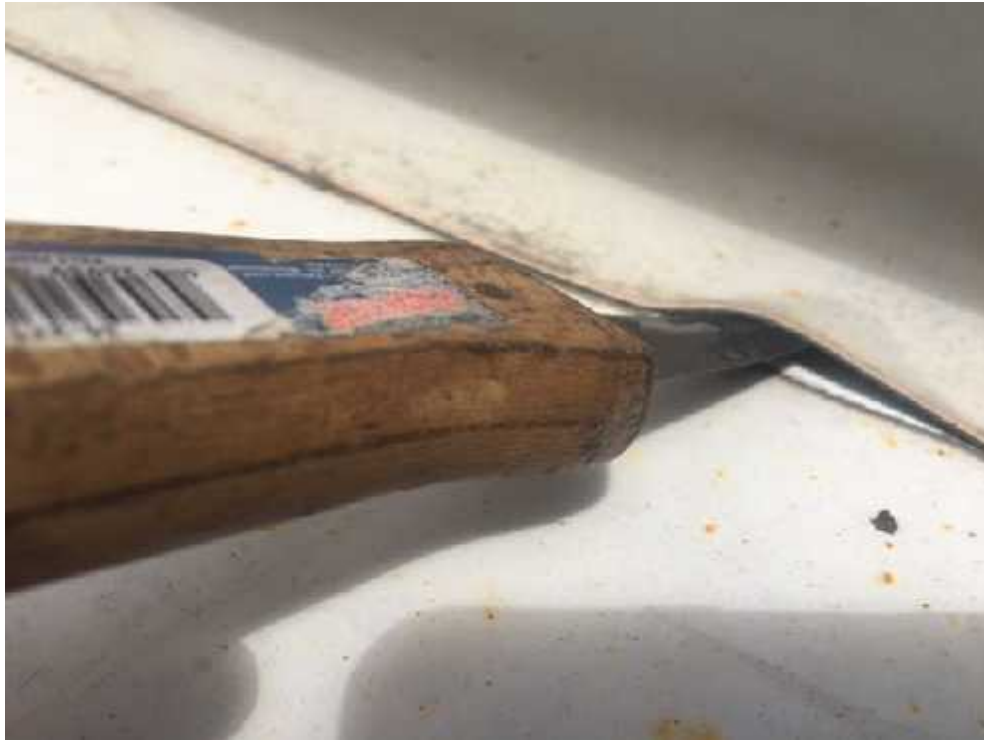
Photograph 36: Roof Area 1.3 – poor heat welding has resulted in seam failure.
